**Evaluation of the
Gilbert Demonstration**

Attorneys for
Toyota Motor Corporation and
Toyota Motor Sales, USA, Inc.

March 2010

Doc no. 0907698.000 A0T0 0310 GILB

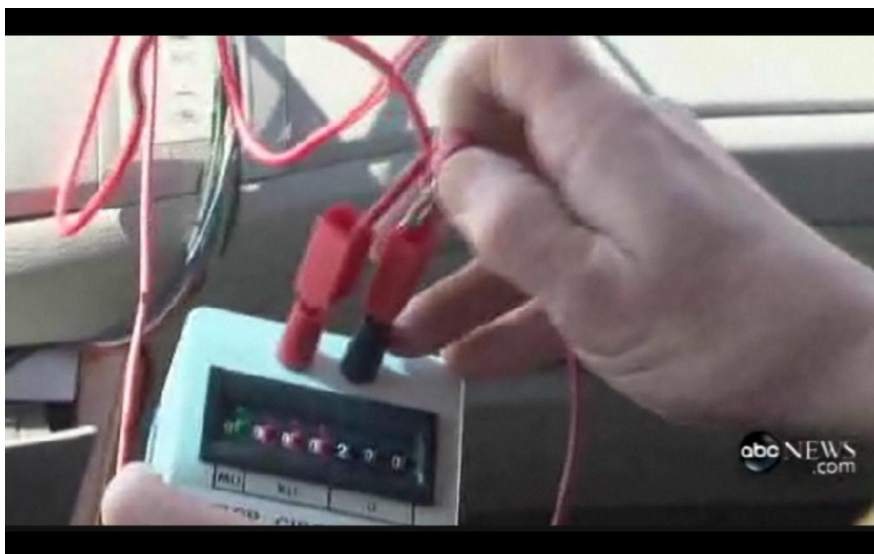
Figure 1. A 200-ohm resistance is apparently connected between the output signals of the two pedal position sensors. A third wire is about to be inserted into one side of the resistance.

Dr. Gilbert intentionally created two sequential faults. The first fault required that the insulation be mechanically defeated on the wires carrying the two pedal position sensor outputs, and then required connecting these two wires with a carefully chosen resistor. The second fault required that more insulation be mechanically defeated on a power supply wire and then formed a low resistance connection between this wire and the output of pedal position sensor #2. These faults must be mechanically created in the prescribed sequence and with strict limits on the value of the resistance between the insulation defeats to avoid detection by the ECM. This will be discussed more fully in a later section.

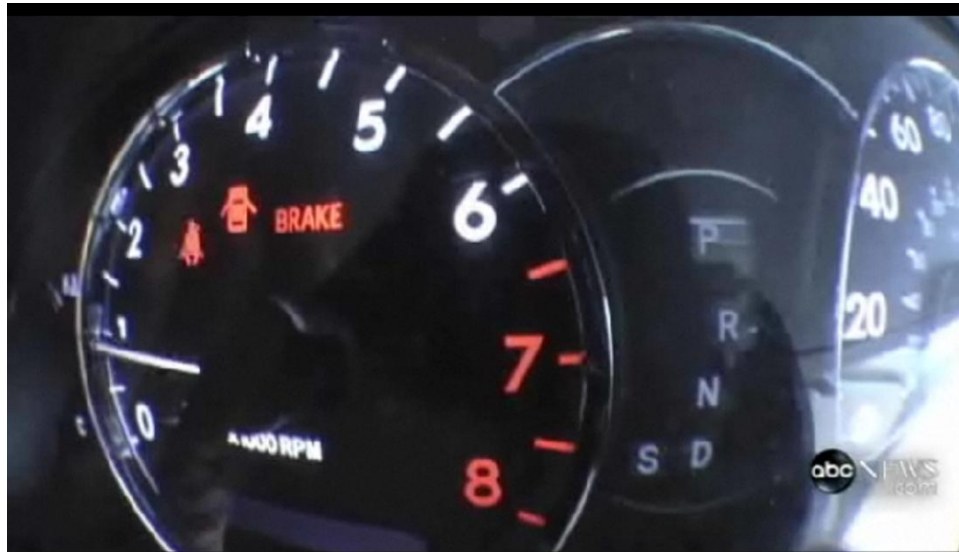
Figure 2. Idle speed condition of the vehicle prior to connecting the power supply to the resistor, ABC video at 2:15.

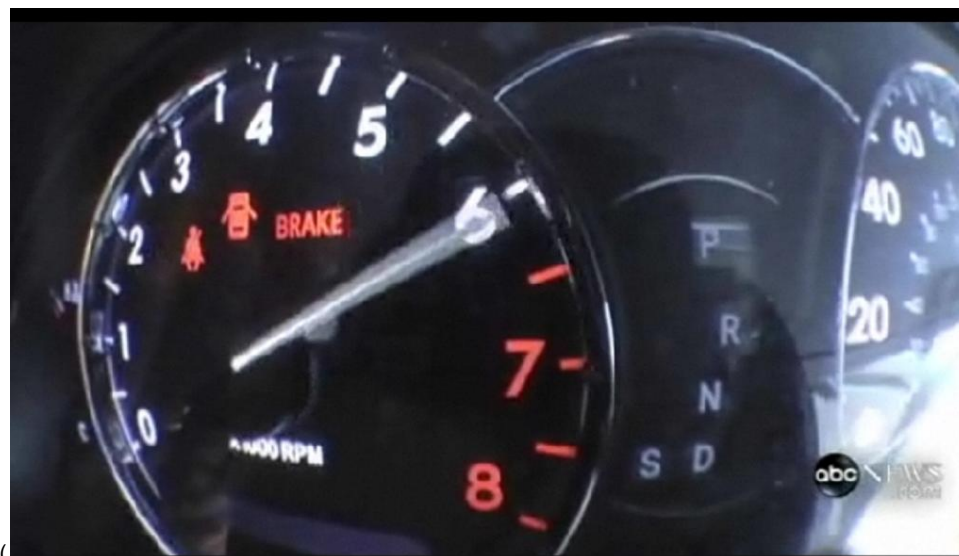
Figure 3. High engine speed resulting from signal manipulations, ABC Video at 2:15.

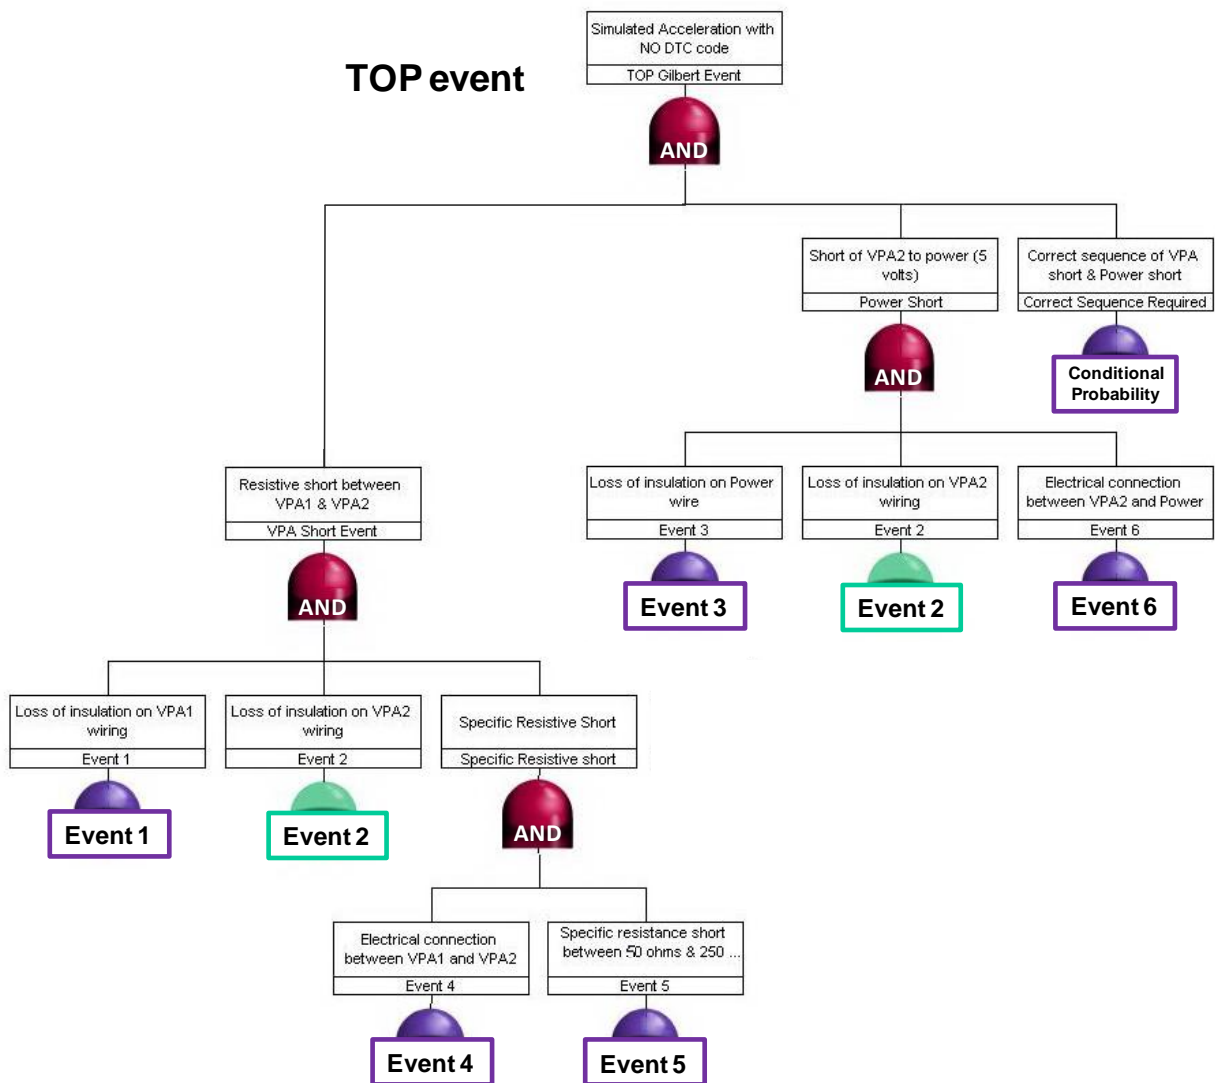
Our analysis illustrates that Dr. Gilbert's scenario requires a complex combination of multiple faults or failures, and that these faults must occur in a precise sequence to produce the "Top" failure event, namely an unintended engine revving with no DTC. These fault events and conditional probabilities are identified as follows:

Figure 5. Fault tree analysis for Gilbert demonstration (Avalon).

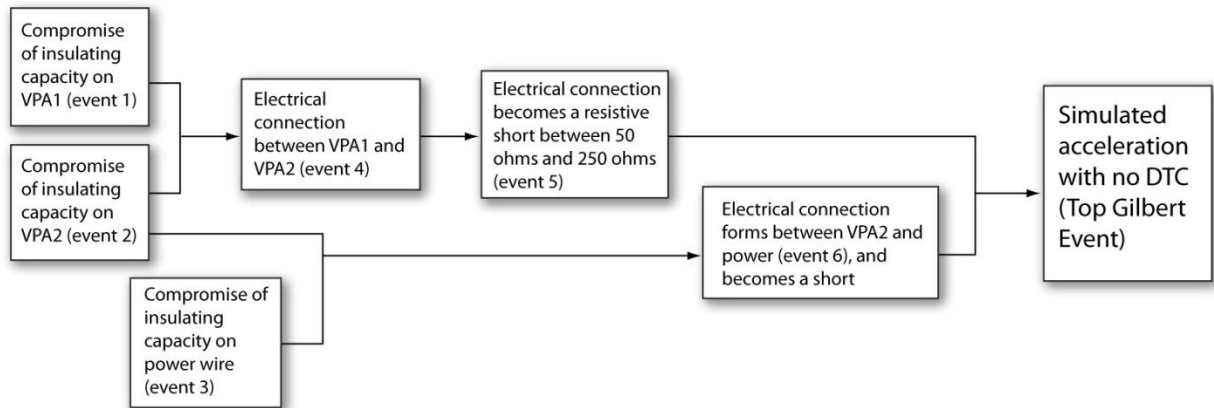
Figure 6. Flowchart of events for Gilbert demonstration (Avalon).

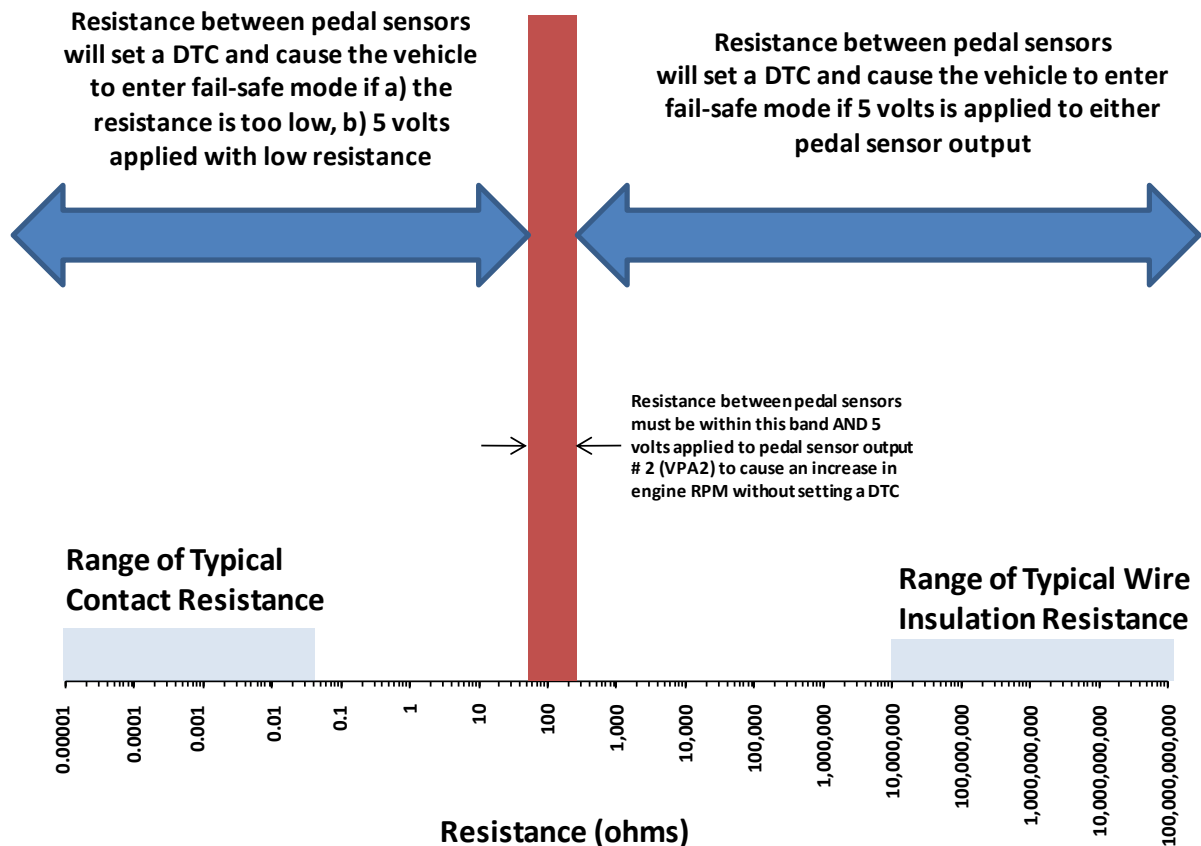
Exponent has performed testing and analysis to determine the range of electrical resistances for the 2010 Avalon that would result in the simulated acceleration. It was determined that the necessary resistance must be between approximately 50 and 250 ohms. Resistances outside this range may result in a DTC. Figure 7 summarizes this finding and illustrates the narrow range of resistances to which Dr. Gilbert's demonstration is confined. It is highly unlikely that a fault could be created under real world conditions that would land in this narrow band of electrical resistances (and stay there) without setting a DTC.

Figure 7. Effect of different resistances placed between pedal sensor wire outputs (VPA1 and VPA2).

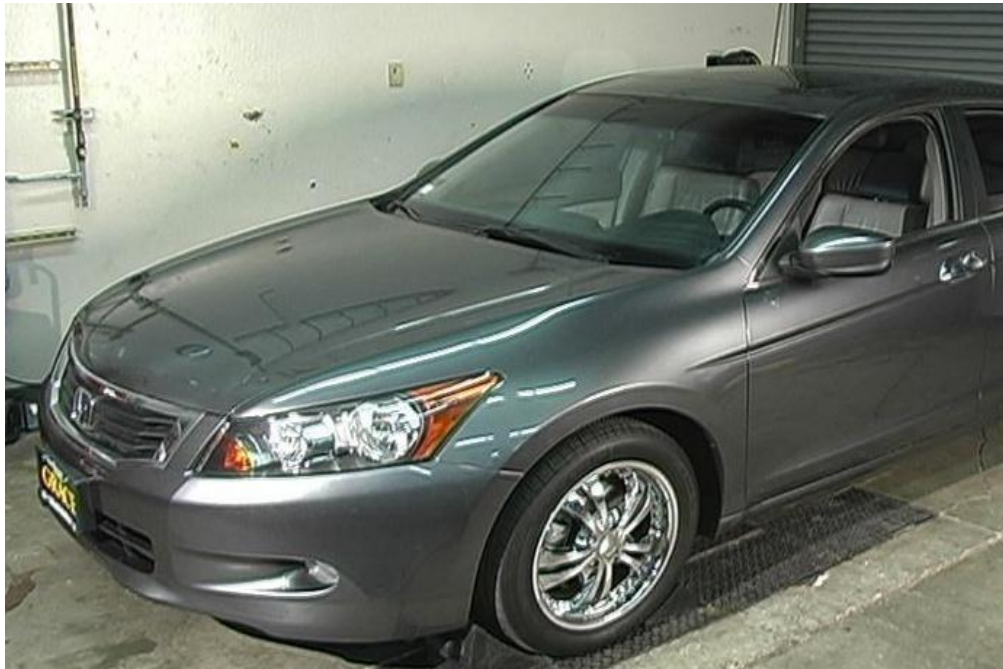
Figure 10. Tested 2008 Honda Accord.

Dr. Gilbert's protocol was applied to the 2008 Honda Accord shown in Figure 10.¹⁴ As with the Avalon and Camry, this involved mechanically creating two sequential electrical faults. Exponent inserted a set of jumper wires between the pedal assembly and the wiring harness connector to the pedal. The jumper wires enabled electrical interconnections between the wires that carry power and position signals between the accelerator pedal and the ECM. Through testing, it was found that a 300-ohm resistor could be used between the two pedal sensor output wires without setting a DTC. Using the jumper wires, the two pedal sensor output wires were connected through a 300-ohm resistor. This resistance is comparable, though slightly higher than the value of the resistor used on the 2010 Avalon by Dr. Gilbert. To cause an increase in engine speed, Exponent connected a 5-volt power supply wire to the accelerator pedal through a

second resistor of 50 ohms.¹⁵ The demonstration on the 2008 Honda Accord resulted in an apparent “sudden” onset of acceleration and engine revving, similar to that shown in Dr. Gilbert’s demonstration. The apparent “sudden” onset of the acceleration was due to artificially creating the second fault in an instantaneous manner.

During the demonstration, the check engine light did not illuminate. After the demonstration, the vehicle’s computer was checked using an OBD-II tool and no diagnostic trouble codes were set. Exponent obtained the same results as those shown by Dr. Gilbert in the ABC News video but with a 2008 Honda Accord. Note that this demonstration was produced under highly artificial conditions where multiple mechanically-created electrical faults and specific resistances were wired into the system through external means to simulate depression of the accelerator pedal. If such circuit faults were to actually occur without deliberate circuit manipulation in an operating vehicle, the presence of such faults would certainly leave “fingerprints” as to their presence.

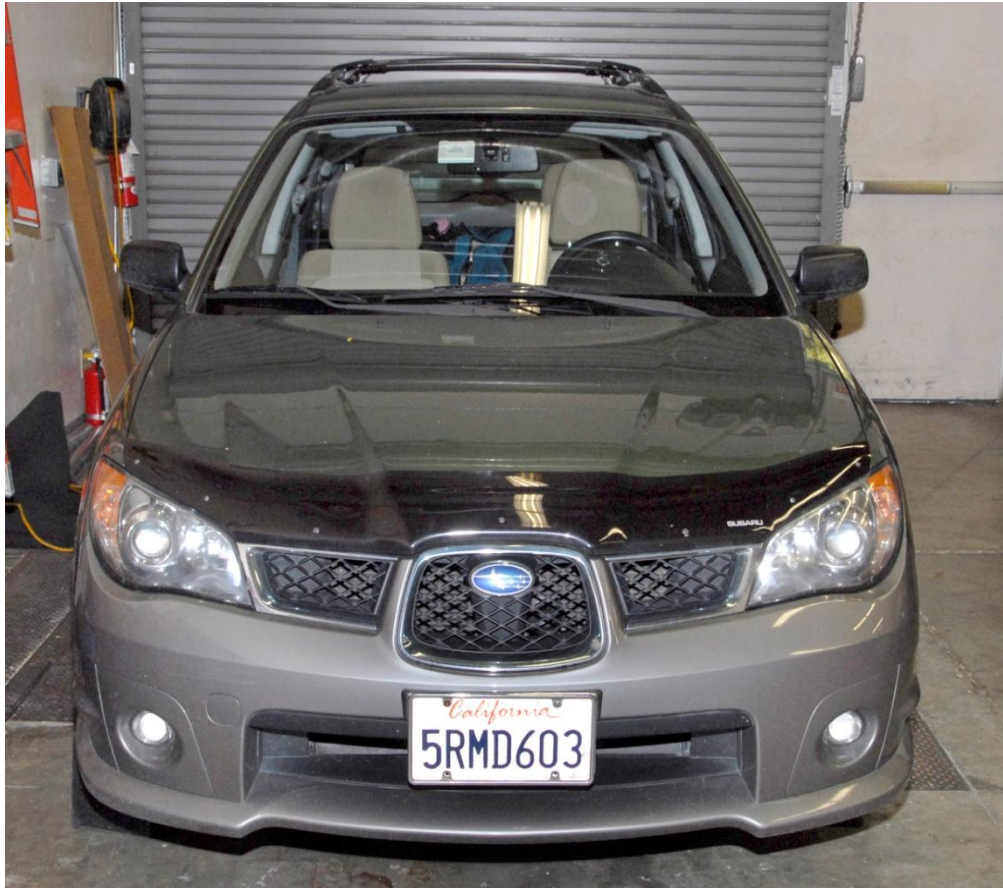
Figure 11. Tested 2006 Subaru Impreza Outback.

Dr. Gilbert's fault creation protocol was applied to the 2006 Subaru Impreza Outback shown in Figure 11.¹⁶ As with the Avalon and Camry, this involved mechanically creating two sequential electrical faults. Exponent inserted a set of jumper wires between the pedal assembly and the wiring harness connector to the pedal. The jumper wires enabled electrical interconnections between the wires that carry power and position signals between the accelerator pedal and the ECM. Using these jumper wires, the two pedal sensor output wires were connected through a 100-ohm resistor. To cause an increase in engine speed, Exponent connected a 5-volt power supply wire to the accelerator pedal through a second resistor of 50 ohms.¹⁷ The demonstration on the 2006 Subaru Impreza Outback resulted in an apparent "sudden" onset of acceleration and engine revving, similar to that shown in Dr. Gilbert's demonstration. The apparent "sudden" onset of the acceleration was due to artificially creating the second fault in an instantaneous manner.

During the demonstration, the check engine light did not illuminate. After the demonstration, the vehicle's computer was checked using an OBD-II tool, and no diagnostic trouble codes were set. Exponent obtained the same results as those shown by Dr. Gilbert in the ABC News video but with a 2006 Subaru Impreza Outback. Note that this demonstration was produced under highly artificial conditions where multiple mechanically-created electrical faults, specific resistances, and power supplies were wired into the system through external means to simulate depression of the accelerator pedal. If such circuit faults were actually to occur without deliberate circuit manipulation in an operating vehicle, the presence of such faults would certainly leave "fingerprints" as to their presence.

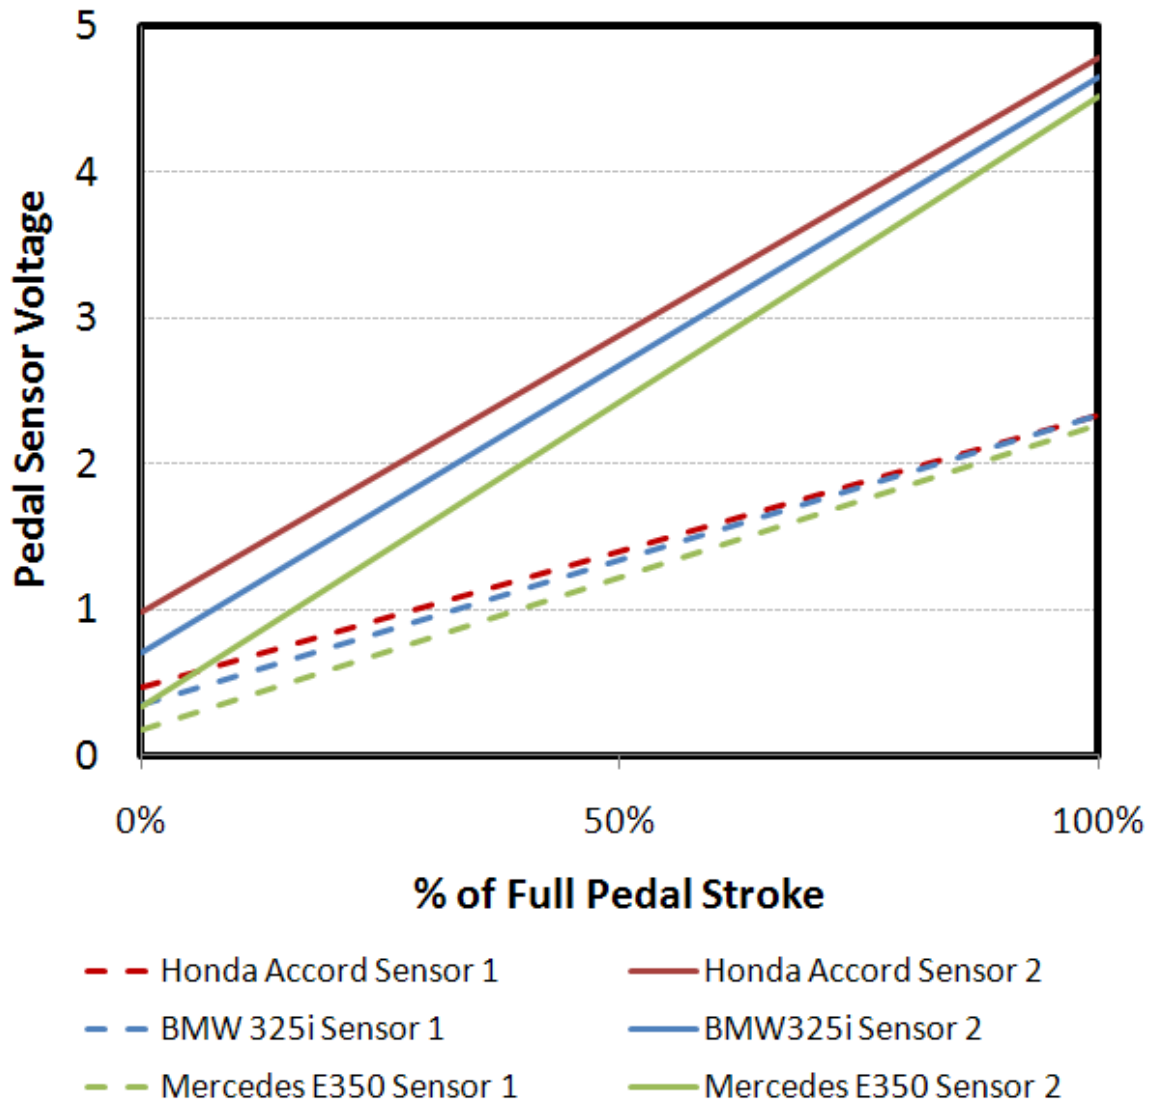
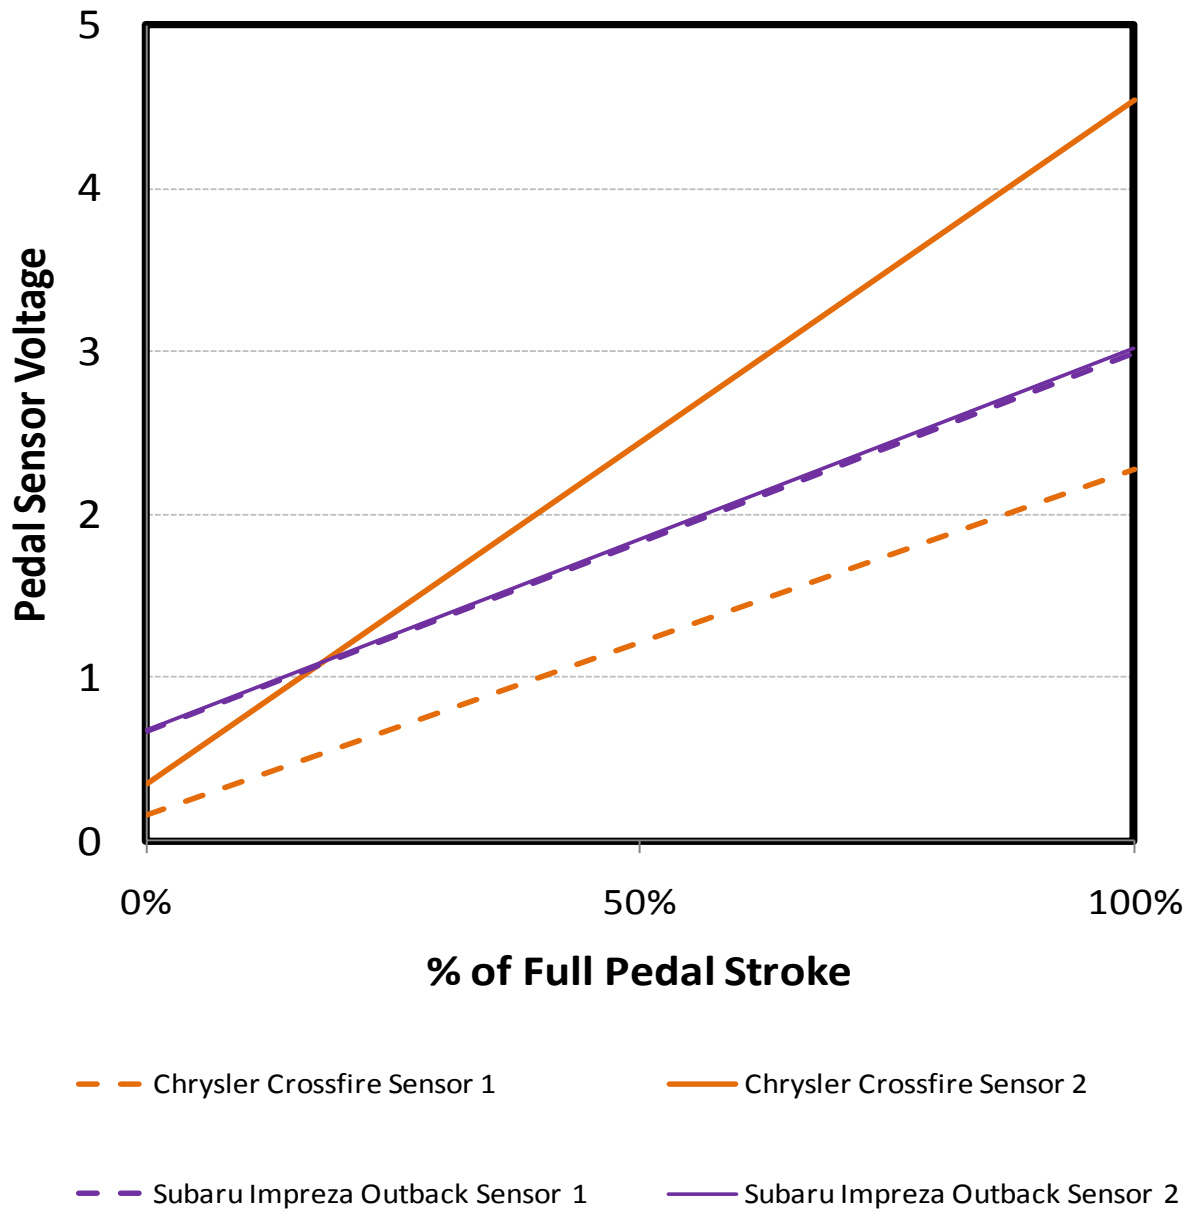
The accelerator pedal sensor output voltages for the 2008 Honda Accord, 2009 Mercedes E350, 2003 BMW 325i, 2005 Chrysler Crossfire, and 2006 Subaru Impreza Outback were measured for different pedal positions. The results of those measurements are shown in Figure 13 and Figure 14. For the Subaru, the two accelerator pedal position sensors produce parallel and nearly identical output voltages. For the other vehicles, the line slopes for sensor 1 and sensor 2 are different and not parallel to each other. Dr. Gilbert opined in his report that several vehicle manufacturers currently use this fault detection strategy and that a short between the two pedal sensor outputs would be detected by the ECM.²⁰ However, tests with pedal position sensors from five other manufacturers using his strategy demonstrate that the electrical wiring to the pedal can also be manipulated to create an apparent “sudden” onset of acceleration and engine revving.

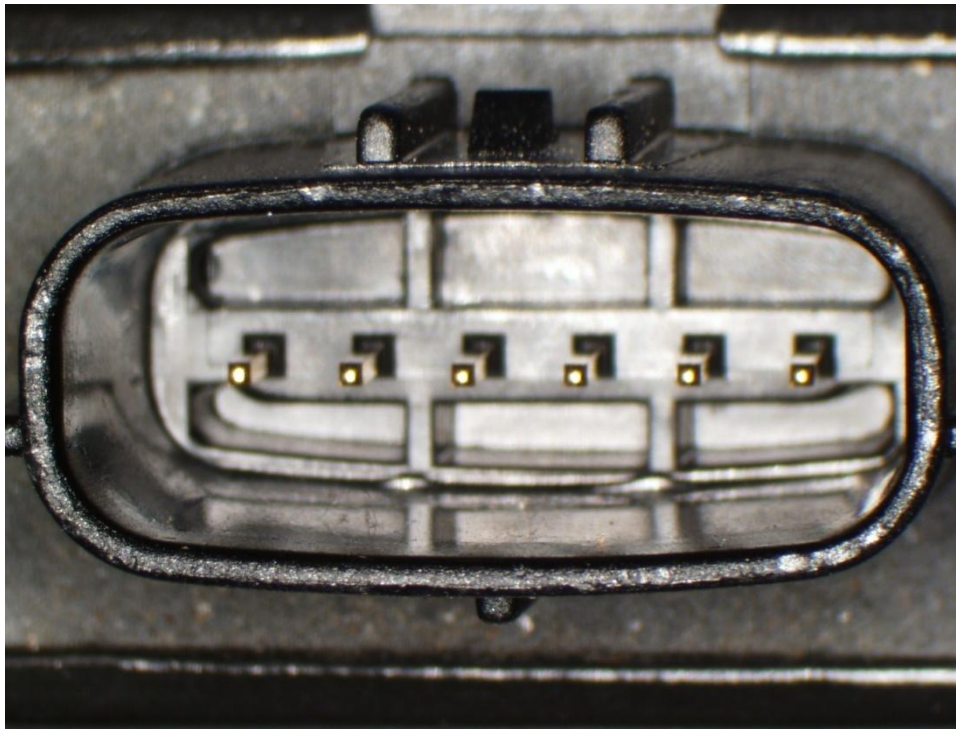
Figure A1. Male portion of connector.

The pedal assembly male connector (shown in Figure A1) is a molded part attached to the pedal assembly. It has the following characteristics:

- Plastic shell surrounds pins of connector protecting them against direct moisture contact
- Connector pins are located on raised pedestal.
- Connector shell has locking mechanism that interlocks the two-connector portions to prevent connector separation and maintain a seal.

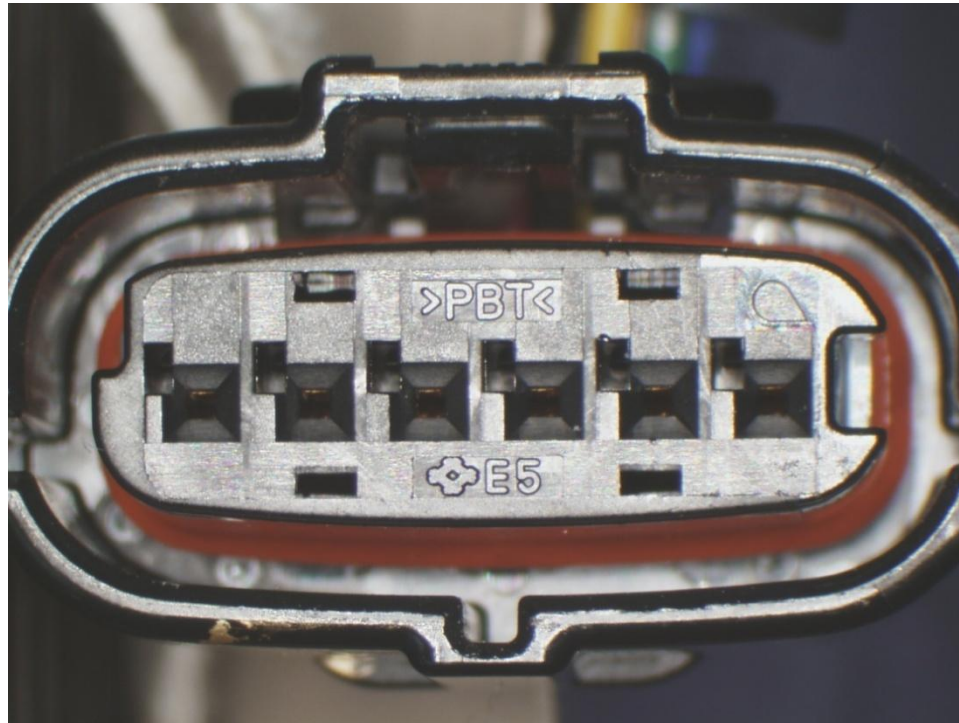
- Plastic shell surrounds housing of male portion to prevent direct moisture contact.
- Rubber gasket surrounds rim of female portion making connector waterproof.
- Each pin fits into its own insulated slot to electrically isolate pins from each other.
- Recessed pin sockets reduce the possibility of adjacent pin electrical interconnection on the female side of the connector.
- Plastic divider extends into the connector further reducing the possibility of adjacent pin electrical interconnection.
- Connector wires are individually insulated.
- Wires are individually sealed with separate cylindrical grommets
- Wires are spaced to prevent adjacent wire contact.

Figure A2. Plastic connector shell surrounds inner connector pedestal to house female sockets. Rubber gasket helps make the connector waterproof. Recessed pins and insulating divider between pins electrically isolates adjacent sockets.

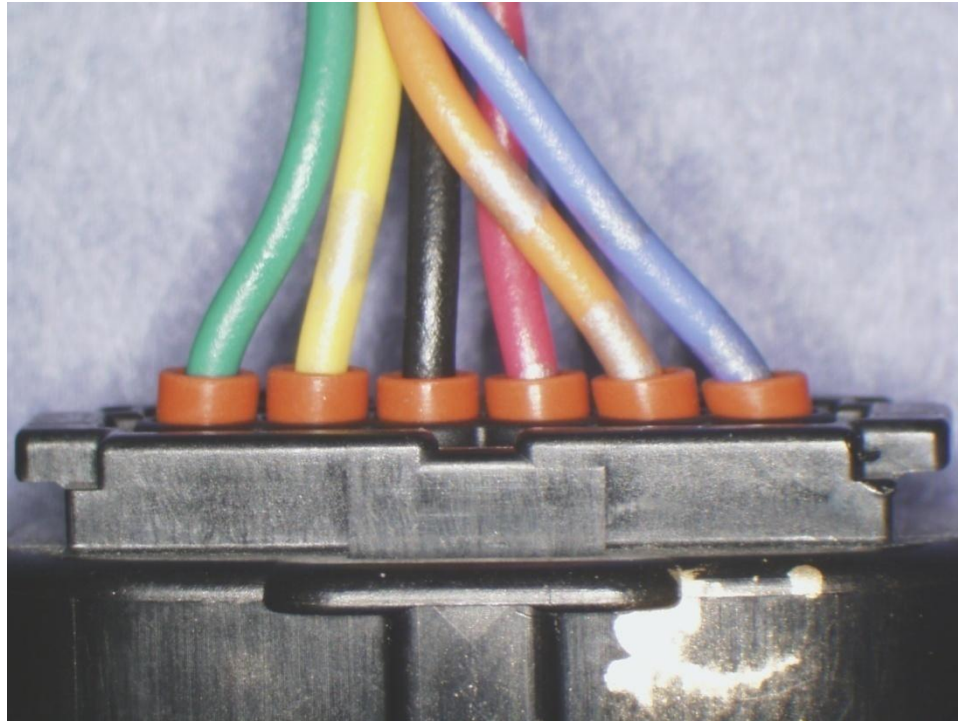
Figure A3. Each connector lead is insulated and protected by a polymeric grommet that helps make the connector waterproof and provides another layer of electrical isolation between sockets.
