**Evaluation of the
Gilbert Demonstration**

Attorneys for
Toyota Motor Corporation and
Toyota Motor Sales, USA, Inc.

March 2010

Doc no. 0907698.000 A0T0 0310 GILB

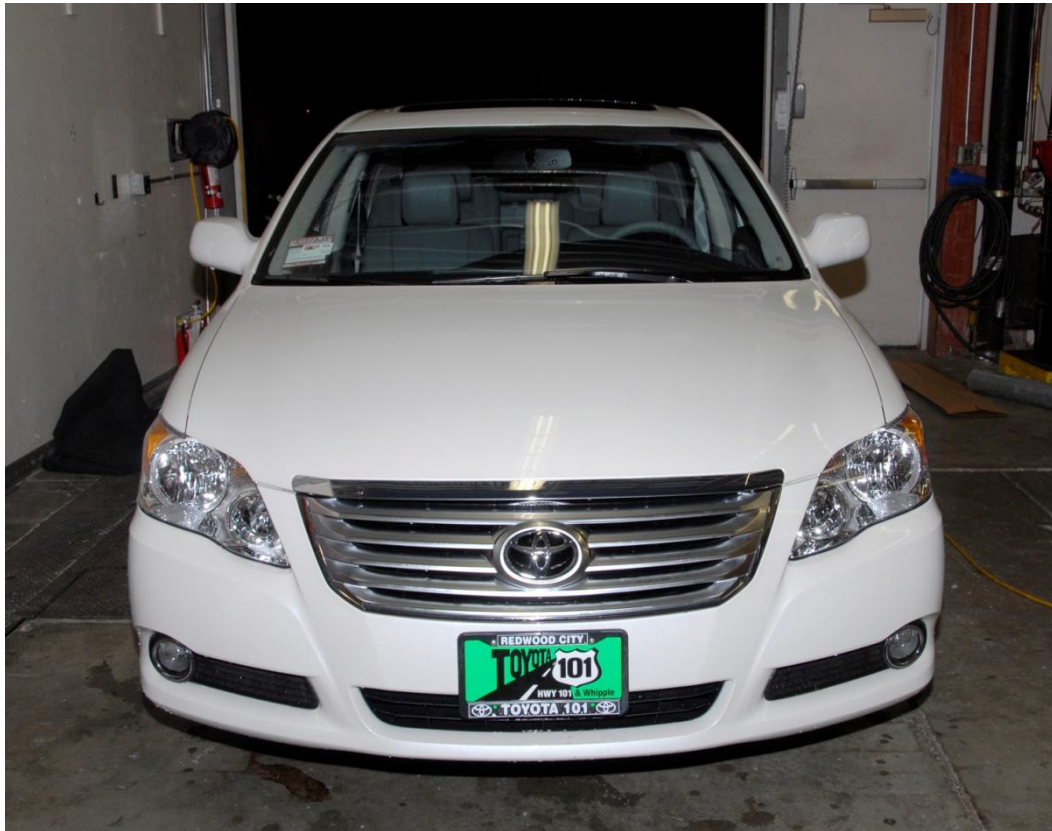
Figure 4. Tested 2010 Toyota Avalon.

Exponent recreated Dr. Gilbert's demonstration using the 2010 Avalon shown in Figure 4.⁵ This involved precise mechanical creation of two sequential wiring faults. Exponent inserted a set of jumper wires between the pedal assembly and the wiring harness connector to the pedal. The jumper wires enabled electrical interconnections between the wires that carry power and pedal position signals between the accelerator pedal and the ECM. The two wires that carry the pedal position signals from the accelerator pedal to the ECM were electrically connected through a 200-ohm resistance. Adding the resistance did not noticeably change the operation of the engine, though increasing or decreasing this resistance more than a limited amount would set a DTC (immediately if the resistance was too low, or later when the second fault was created.) To cause an increase in engine speed, Exponent then connected one of the 5-volt power supply wires from the accelerator pedal to the secondary accelerator pedal position signal wire (VPA2) using another jumper wire. Exponent's recreation of the Gilbert demonstration on the Avalon resulted in an apparent "sudden" onset of acceleration and engine revving, similar to that shown in Dr. Gilbert's demonstration. The apparent "sudden" onset of the acceleration was due to artificially creating the second fault in an instantaneous manner after the carefully engineered first fault.

circuit manipulation in an operating vehicle, the physical presence of such faults would unquestionably leave “fingerprints,” as discussed later.

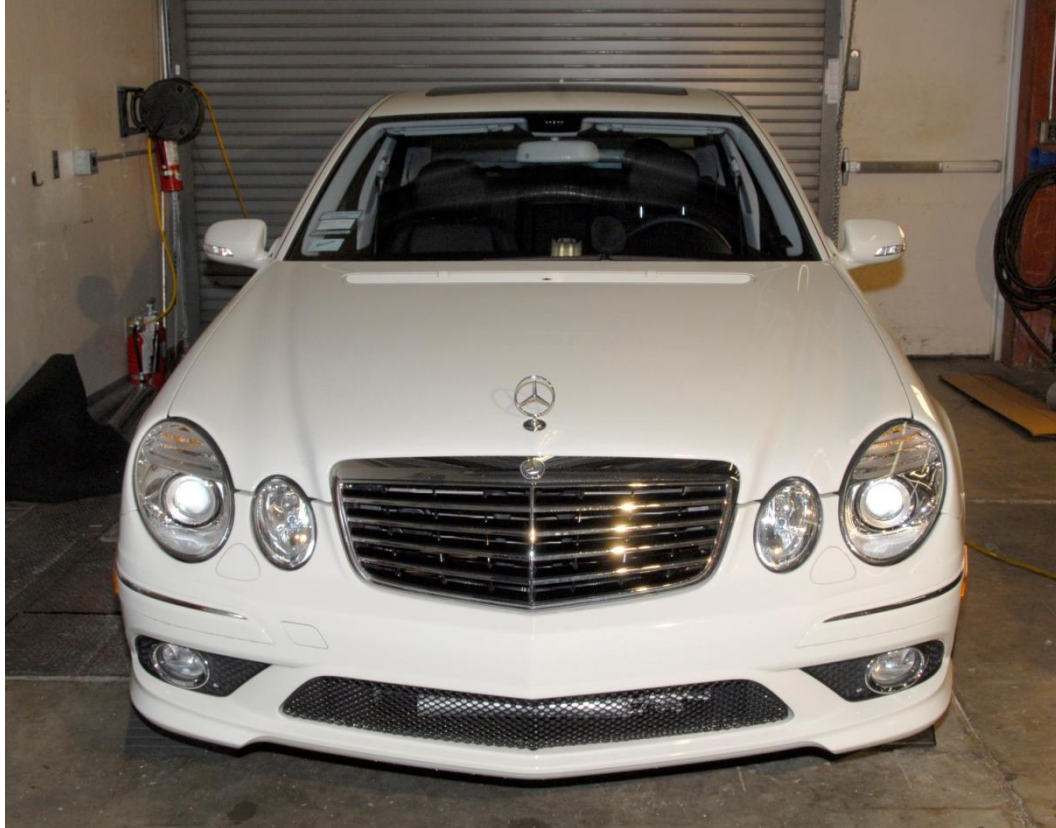
Figure 8. Tested 2009 Mercedes E350.

Dr. Gilbert's fault creation protocol was applied to the 2009 Mercedes E350 shown in Figure 8.¹⁰ As with the Avalon and Camry, this involved mechanically creating two sequential electrical faults. Exponent inserted a set of jumper wires between the pedal assembly and the wiring harness connector to the pedal. The jumper wires enabled electrical interconnections between the wires that carry power and position signals between the accelerator pedal and the ECM. Using these jumper wires, the two pedal sensor output wires were connected through a 200-ohm resistor. The resistance value was identical to that used by Dr. Gilbert when he tested his Avalon. To cause an increase in engine speed, Exponent connected a 5-volt power supply wire to the accelerator pedal through a second resistor of 100 ohms.¹¹ The demonstration on the 2009 Mercedes E350 resulted in an apparent "sudden" onset of acceleration and engine revving, similar to that shown in Dr. Gilbert's demonstration. The apparent "sudden" onset of the acceleration was due to artificially creating the second fault in an instantaneous manner.

During the demonstration, the check engine light did not illuminate. After the demonstration, the vehicle's computer was checked using an OBD-II tool and no diagnostic trouble codes were set. Exponent obtained the same results as those shown by Dr. Gilbert in the ABC News video but with a 2009 Mercedes E350 using his protocol. Note that this demonstration was produced under highly artificial conditions where multiple mechanically-created electrical faults, specific resistances, and power supplies were wired into the system through external means to simulate depression of the accelerator pedal. If such circuit faults were actually to occur without deliberate circuit manipulation in an operating vehicle, the presence of such faults would certainly leave "fingerprints" as to their presence.

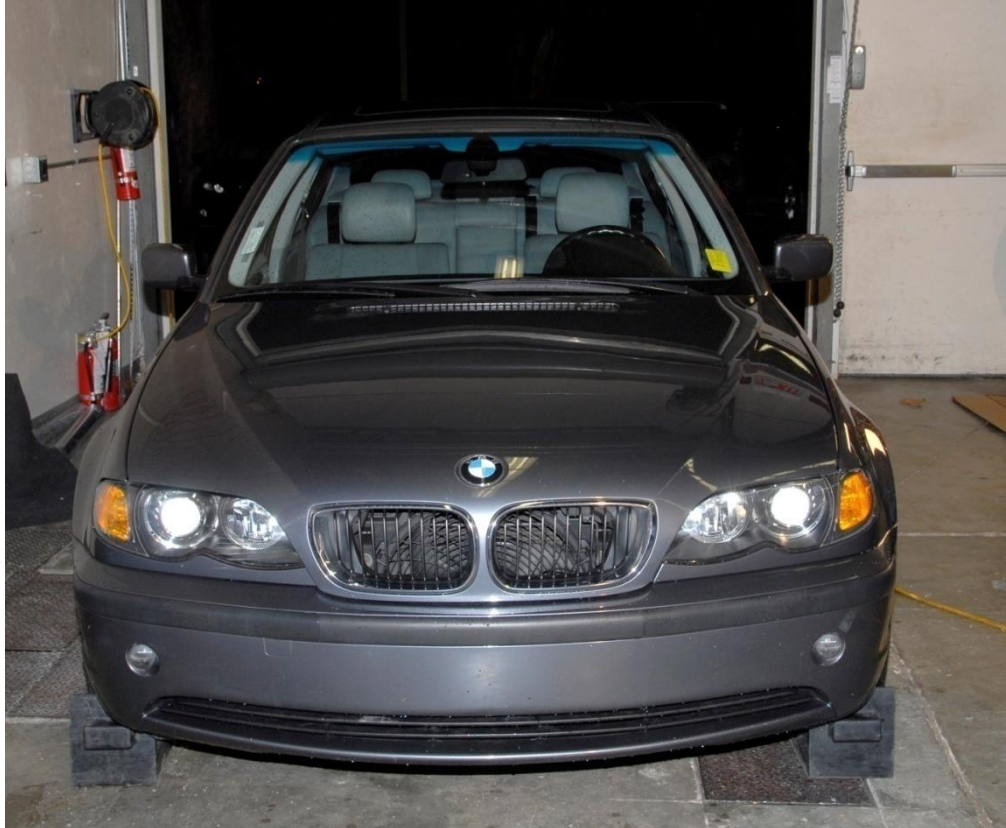
Figure 9. Tested 2003 BMW 325i.

Dr. Gilbert's fault creation protocol was applied to the 2003 BMW 325i shown in Figure 9.¹² As with the Avalon and Camry, this involved mechanically creating two sequential electrical faults. Exponent inserted a set of jumper wires between the pedal assembly and the wiring harness connector to the pedal. The jumper wires enabled electrical interconnections between the wires that carry power and position signals between the accelerator pedal and the ECM. Using these jumper wires, the two pedal sensor output wires were connected through a 200-ohm resistor. The resistance value was identical to that used by Dr. Gilbert when he tested his Avalon. To cause an increase in engine speed, Exponent connected a 5-volt power supply wire to the accelerator pedal through a second resistor of 100 ohms.¹³ The demonstration on the 2003 BMW 325i resulted in an apparent "sudden" onset of acceleration and engine revving, similar to that shown in Dr. Gilbert's demonstration. The apparent "sudden" onset of the acceleration was due to artificially creating the second fault in an instantaneous manner.

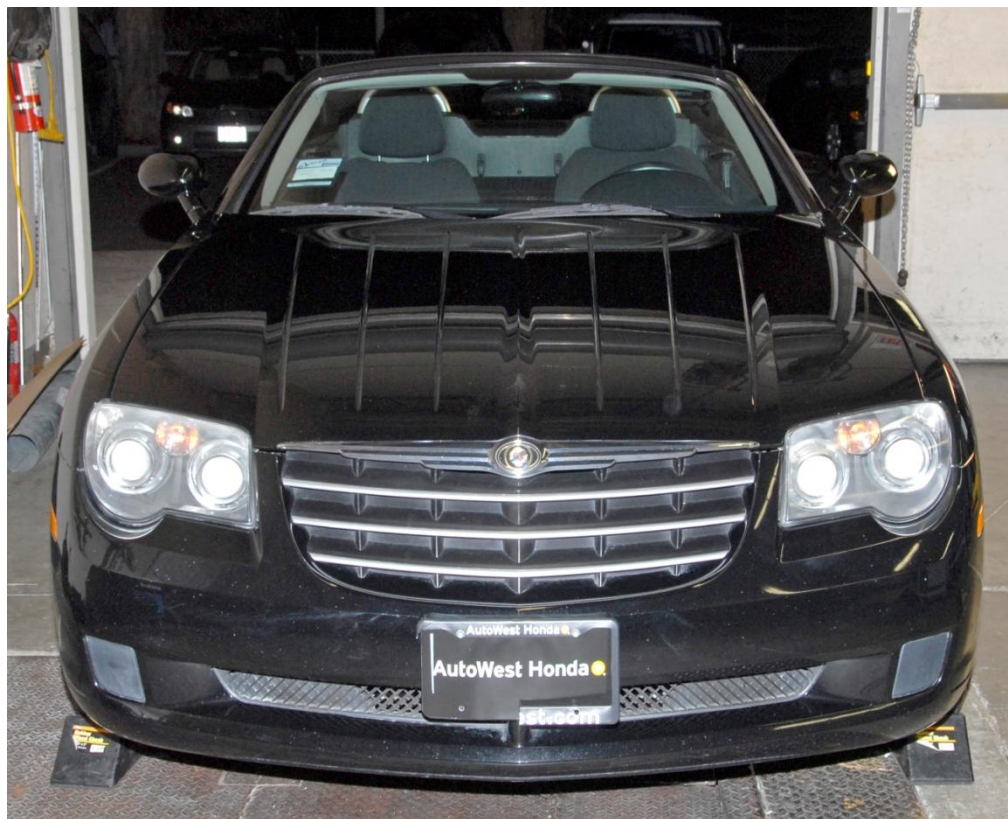
Figure 12. Tested 2005 Chrysler Crossfire.

Dr. Gilbert's fault creation protocol was applied to the 2005 Chrysler Crossfire shown in Figure 12.¹⁸ As with the Avalon and Camry, this involved mechanically creating two sequential electrical faults. Exponent inserted a set of jumper wires between the pedal assembly and the wiring harness connector to the pedal. The jumper wires enabled electrical interconnections between the wires that carry power and position signals between the accelerator pedal and the ECM. Using these jumper wires, the two pedal sensor output wires were connected through a 200-ohm resistor. The resistance value was identical to that used by Dr. Gilbert when he tested his Avalon. To cause an increase in engine speed, Exponent connected a 5-volt power supply wire to the accelerator pedal through a second resistor of 100 ohms.¹⁹ The demonstration on the

2005 Chrysler Crossfire resulted in an apparent “sudden” onset of acceleration and engine revving, similar to that shown in Dr. Gilbert’s demonstration. The apparent “sudden” onset of the acceleration was due to artificially creating the second fault in an instantaneous manner.

During the demonstration, the check engine light did not illuminate. After the demonstration, the vehicle’s computer was checked using an OBD-II tool, and no diagnostic trouble codes were set. Exponent obtained the same results as those shown by Dr. Gilbert in the ABC News video but with a 2005 Chrysler Crossfire. Note that this demonstration was produced under highly artificial conditions where multiple mechanically- created electrical faults, specific resistances, and power supplies were wired into the system through external means to simulate depression of the accelerator pedal. If such circuit faults were actually to occur without deliberate circuit manipulation in an operating vehicle, the presence of such faults would certainly leave “fingerprints” as to their presence.
